1. Purpose and scope of this memorandum

This memorandum summarizes a site survey performed July 5, 2018 to evaluate the condition of ADA mandated access at Stetson Beach in Pembroke Massachusetts. After a description of the site and site uses, recommended improvements are provided in Section 7, beginning on page 2.

3. Name and location of site

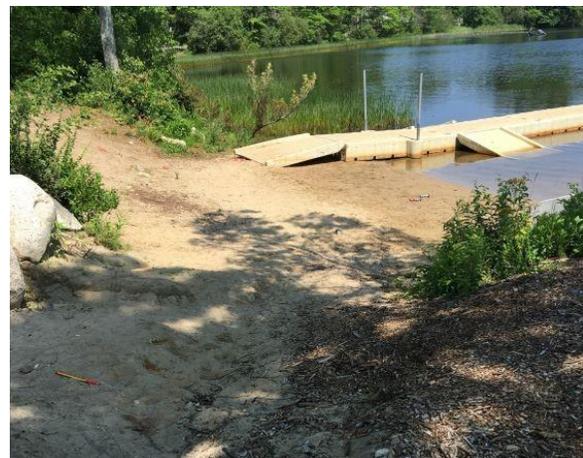
Stetson Park contains a dirt parking area, small float dock at the north side of the parking area and an unimproved boat ramp on the south side to the parking area. Except for the areas immediately adjacent to the float dock and the boat ramp, the shoreline is vegetated. A single portable toilet is placed at the north side of the parking area. Access from the parking area to the float is from a short steep dirt path. Access to the unimproved boat ramp is a graded dirt slope directly from the parking area. There is a public beach sign indicating hours of use and beach rules.
